F: 7-1-15
William and Rachel Proctor Log House
Mt. Ephraim community
Private

INVENTORY FORM FOR STATE HISTORIC SITES SURVEY

William and Rachel Proctor House

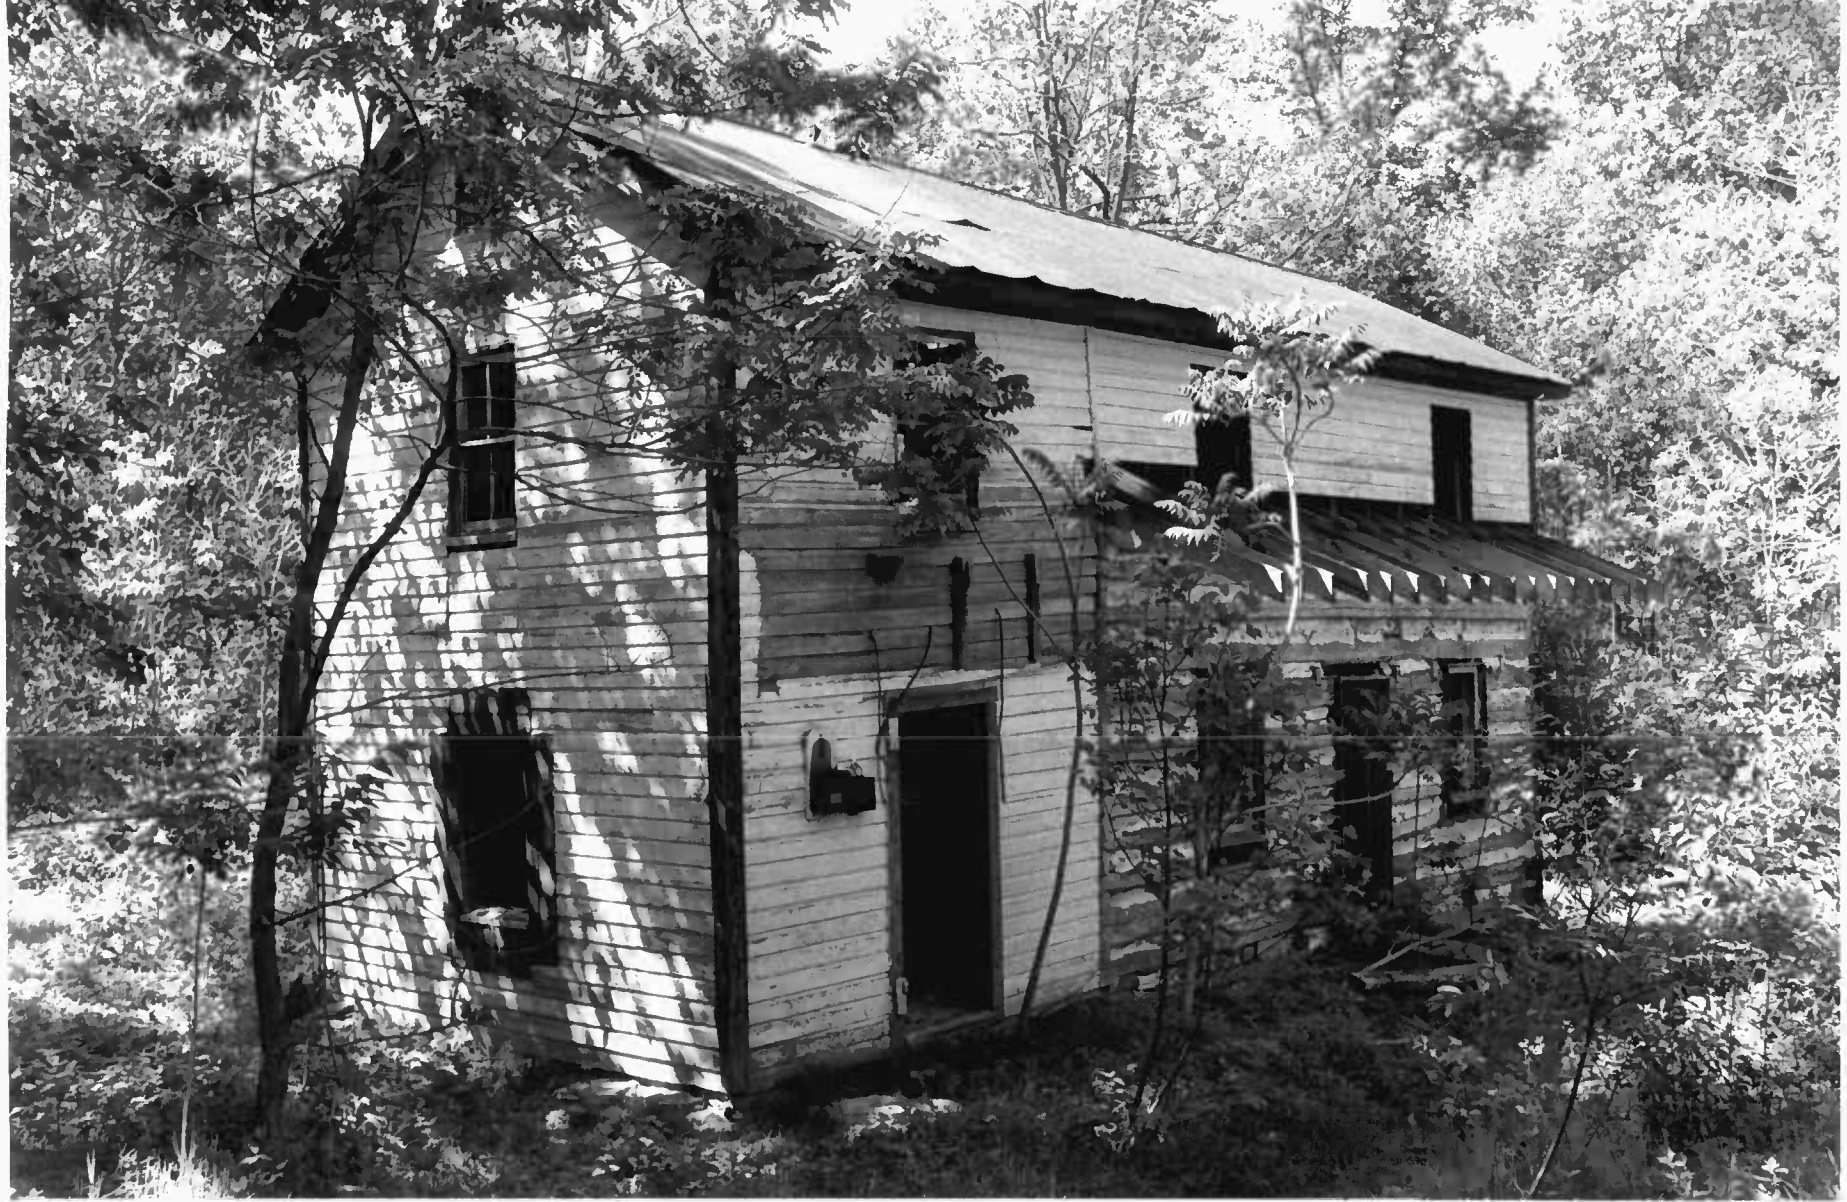
Southeast elevation

At present, the owner is building a new roof, which is roughly the same height of the original one story house. The rafters of the new roof can be seen in the photographs of the house today.

Wm + Rachel Proctor house

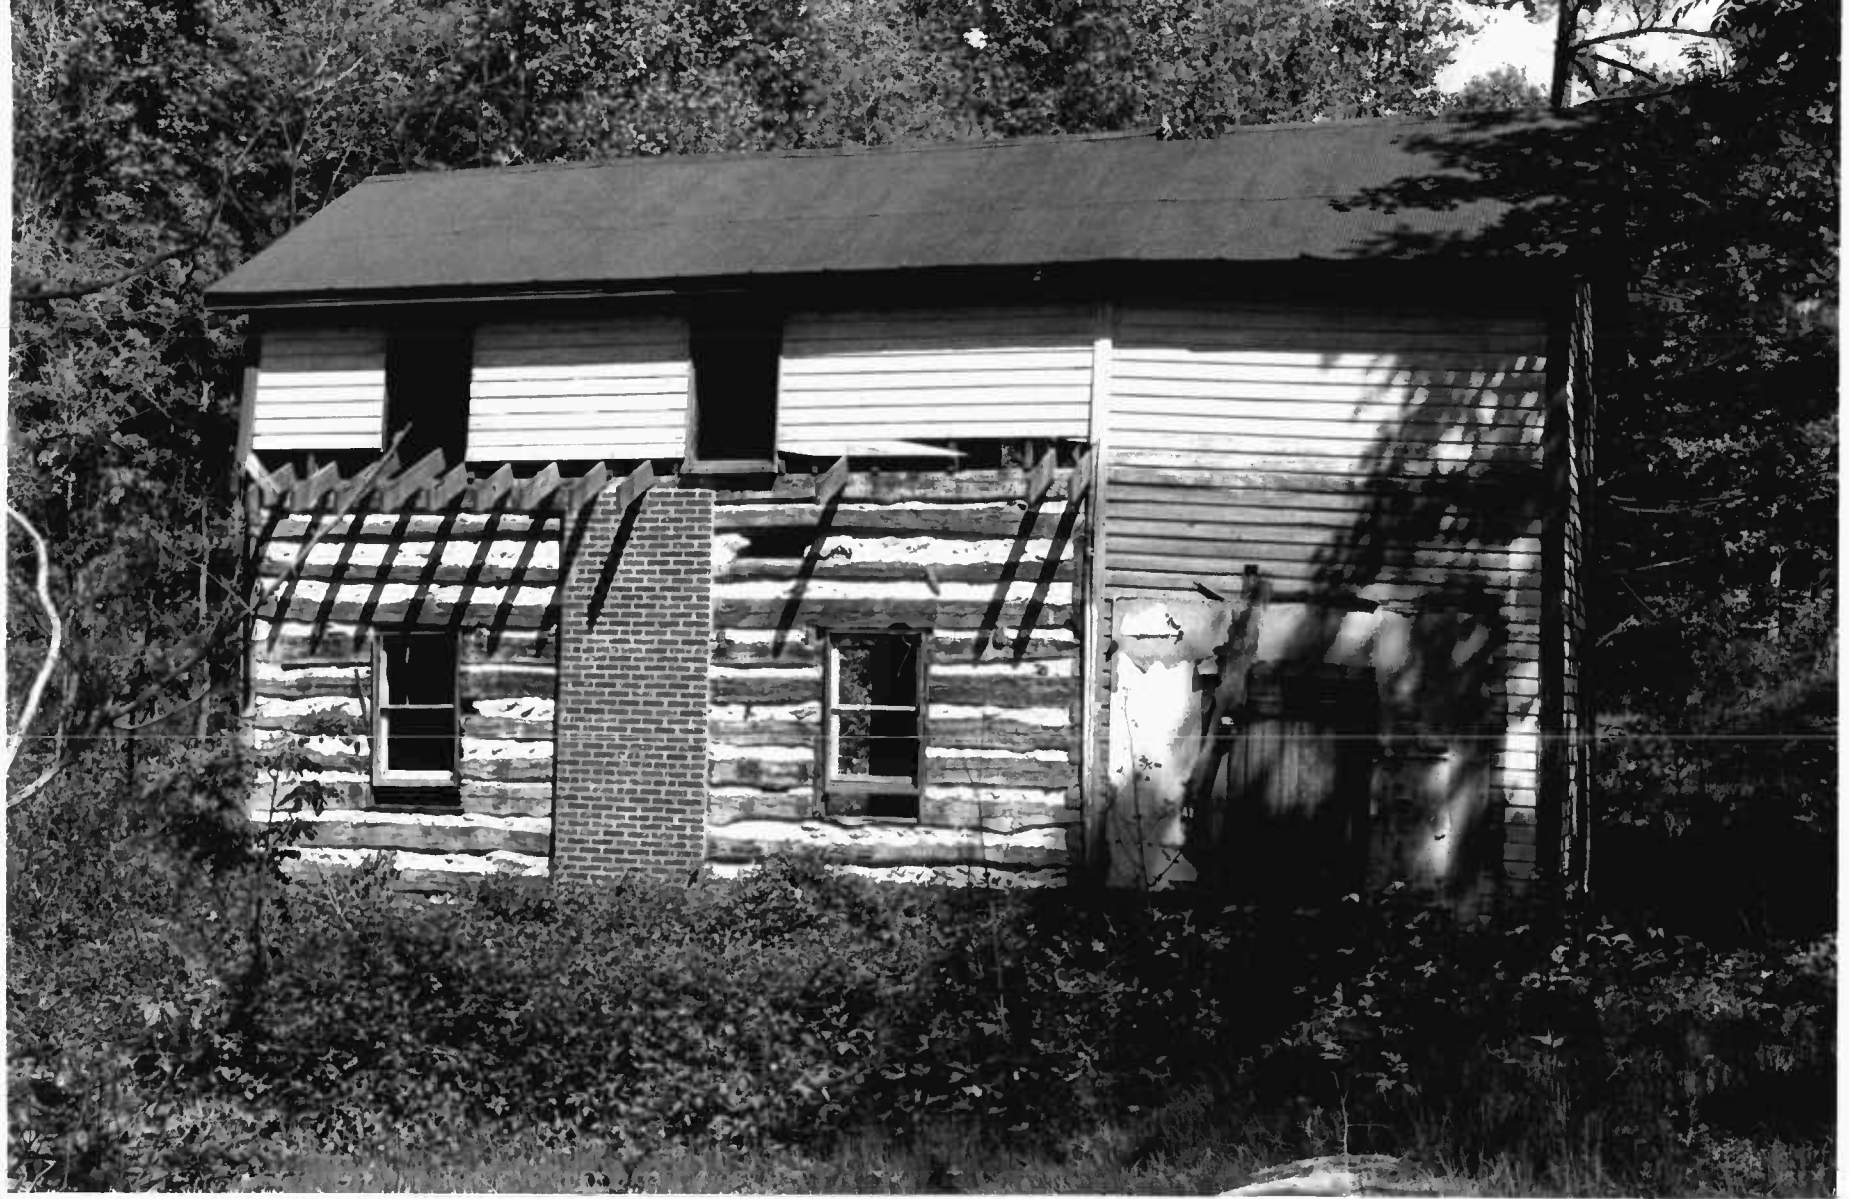
West length of the William
and Rachel Proctor House
F-7-1-15

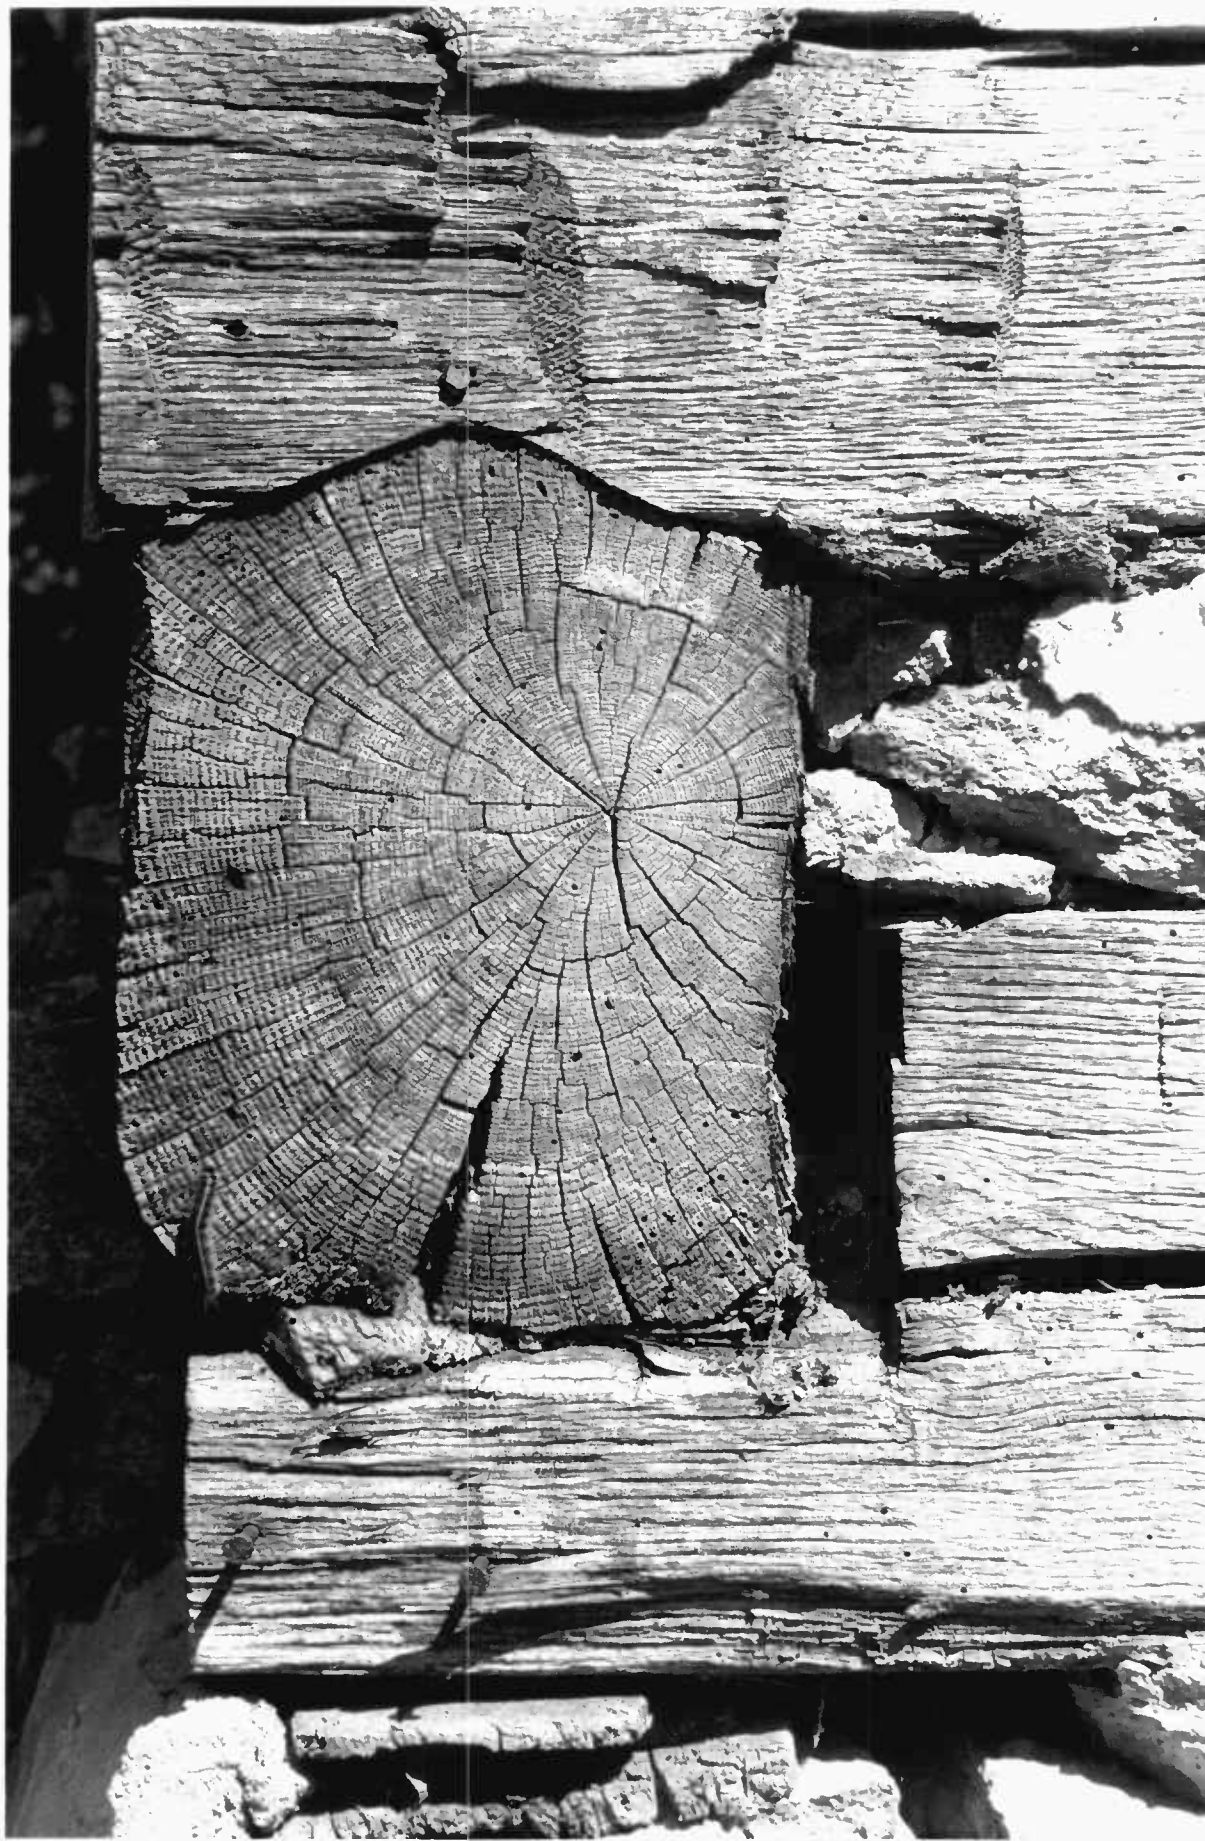
As for log construction, the hewn logs were V-notched at the corners and hewn on two sides. There was no evidence of pegging between the logs.

Log Corner of William & Rachel
Proctor House
